FACILITY COMPLIANCE INSPECTION REPORT

Division of Waste Management Solid Waste Section

Date of Site Inspection: October 24, 2011

Lake Norman Landfill, Inc.
7099 Quarry Lane
Stanley, NC 28164

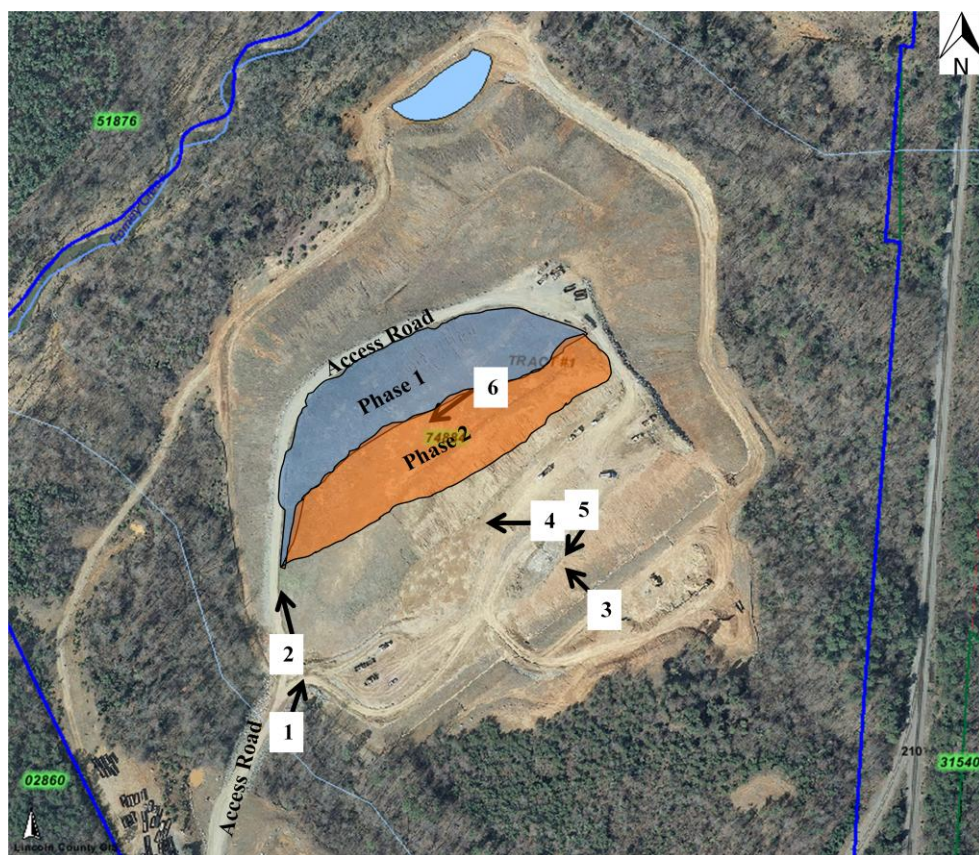
Figure 2: Perspectives of Photos in this Audit

19. The "intermediate" vegetative cover on Phases 1 and 2 (Figure 2) is well established and well maintained.
20. No woody vegetation or trees were observed on the landfill.

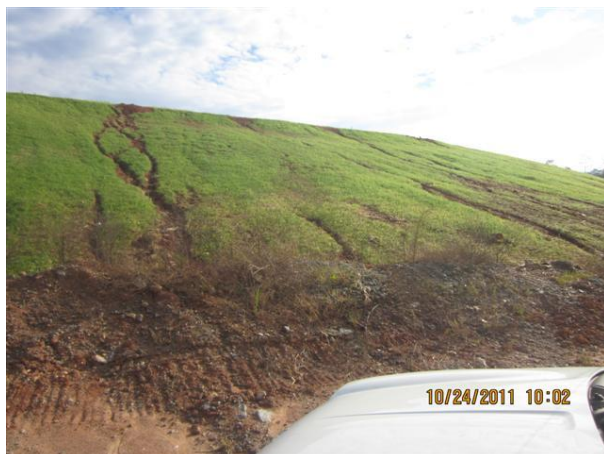
1. On October 24, 2011, multiple areas of excessive surface erosion were observed. These areas on the south and west slopes of the landfill. (Photos #1 through #3, and Figure 2) This constitutes violation of 15 NCAC 13B .0542(k)(2). Over the past month the landfill has multiple rain events (9/21/11, 9/23/11, and 10/19/11) in excess of 1-inch.

1. 10/24/11: Area of erosion on the lower (SW) slopes of the landfill. (See Figure 2)

In order to achieve compliance, Lake Norman Landfill, LLC must immediately take measures to repair eroded areas and control on-site erosion.

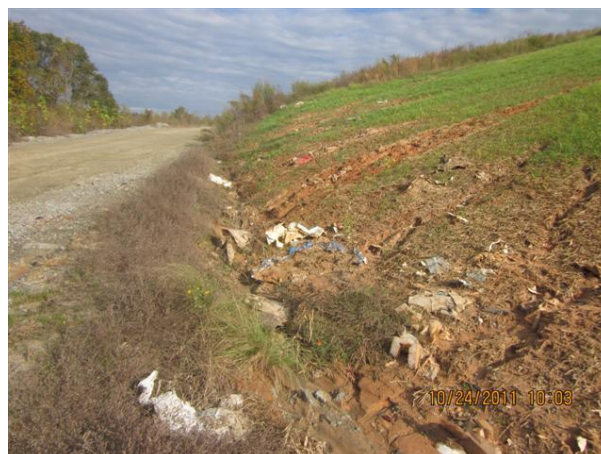
2. 10/24/11: Looking (N) along the access road on the west side of the landfill at surface erosion and exposed waste. (See Figure 2)

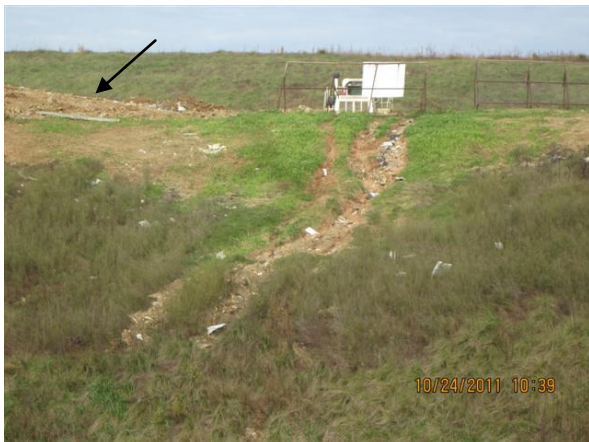
3. 10/24/11 Looking (NW) from the barrow area at excessive erosion of the cap and windblown litter. (Note the working face in the upper left.)

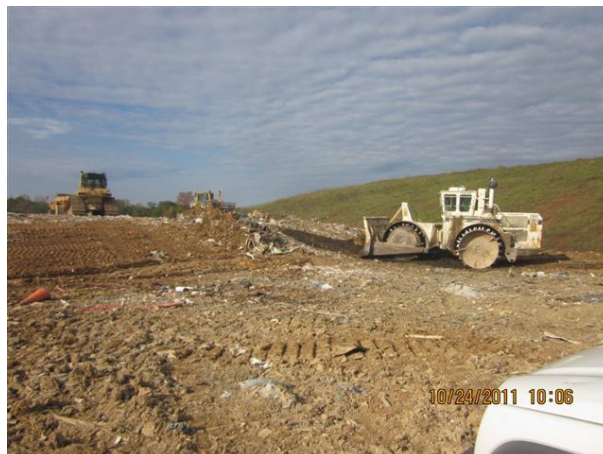
4. 10/24/11 Looking (W) at the active working face – small and well maintained.

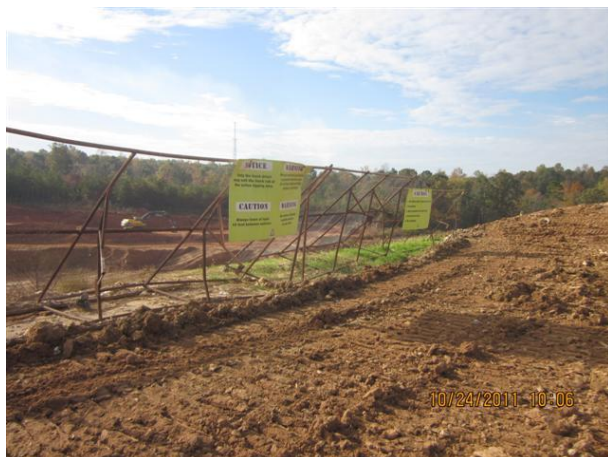
5. 10/24/11 Looking at the movable litter control fence along the (SE) edge of the landfill.

6. The landfill was actively receiving waste during the audit. The operational area/working face was small and well maintained.
7. Several sections of movable fencing are used to capture and control windblown litter. (Photo #5) There was very little windblown material observed during this inspection.

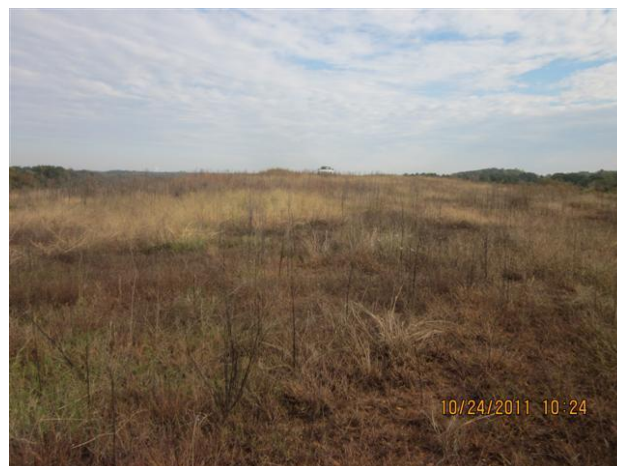
6. 10/24/11: Looking SW across the top of at the intermediate cover on Phases 1A and 1B.
